## What happened and What We did after the Earthquakes in Kumamoto

#### July 7, 2016 JANOG38 LT@Okinawa

Service Operation Center, Technical Division, Kyushu Telecommunication Network Co. (QTNet)

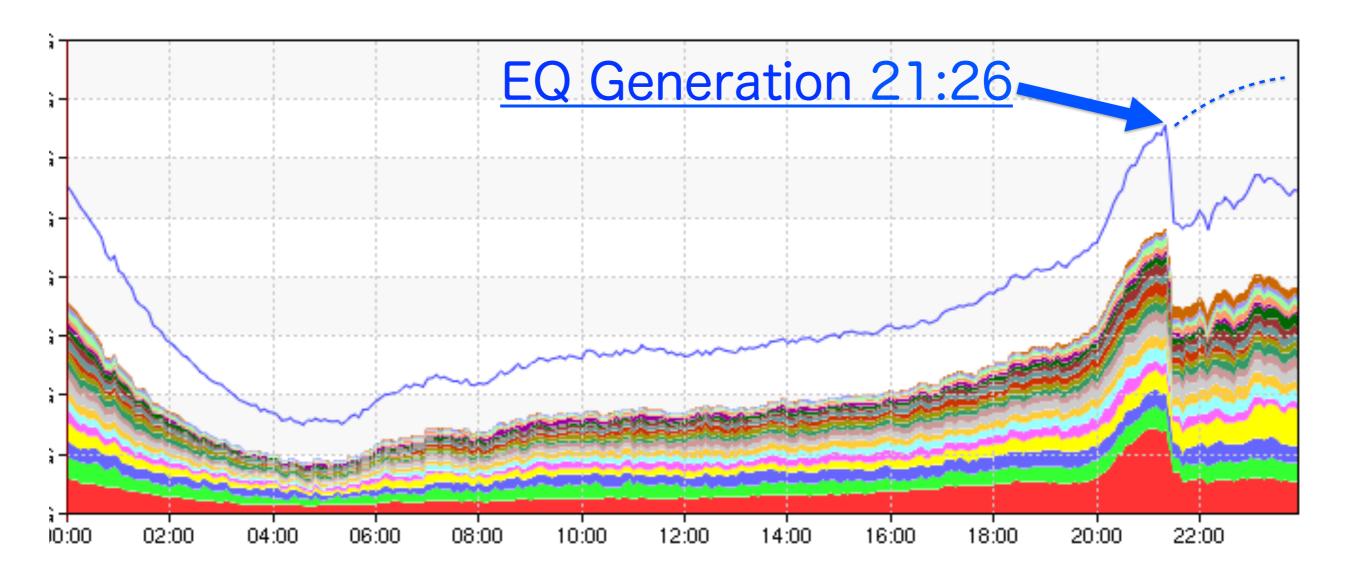
### Internet $\Rightarrow$ AS7679 (Apr. 14 0:00 - 23:59)

### Traffic (Internet)

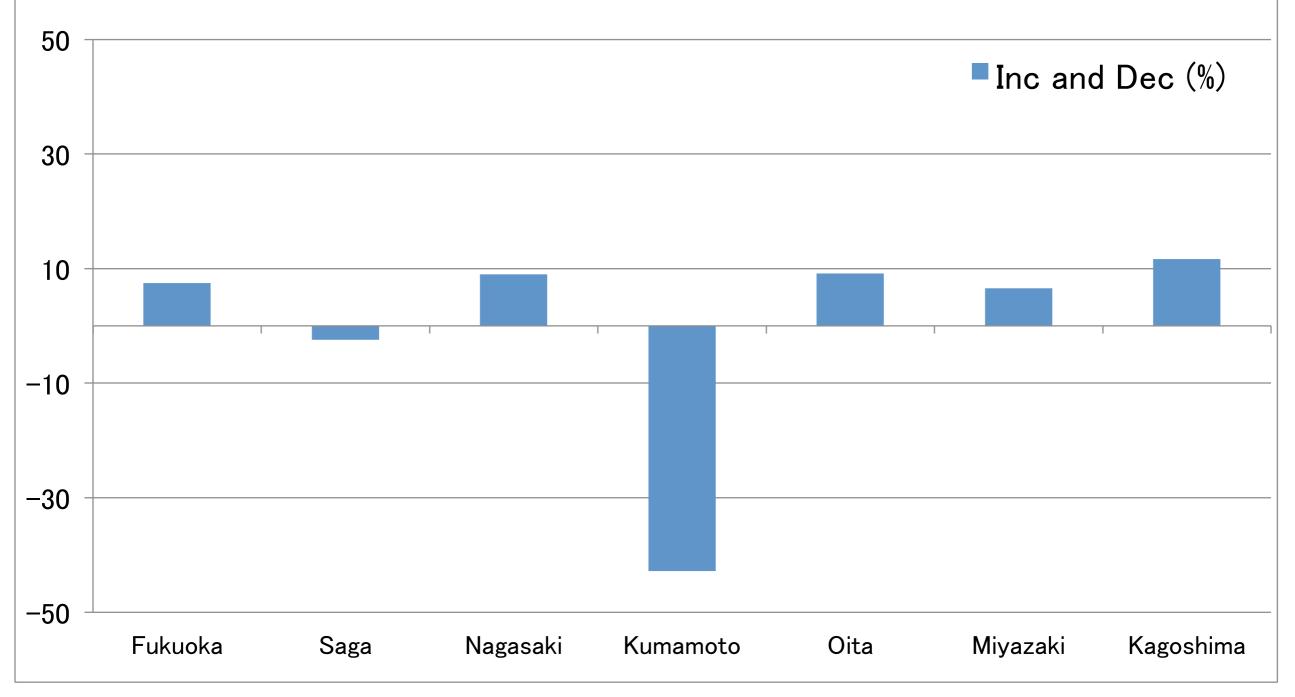
# Percentage of Increase and Decrease of Traffic / Area

(Comparing to 2 hours later from earthquake generation)

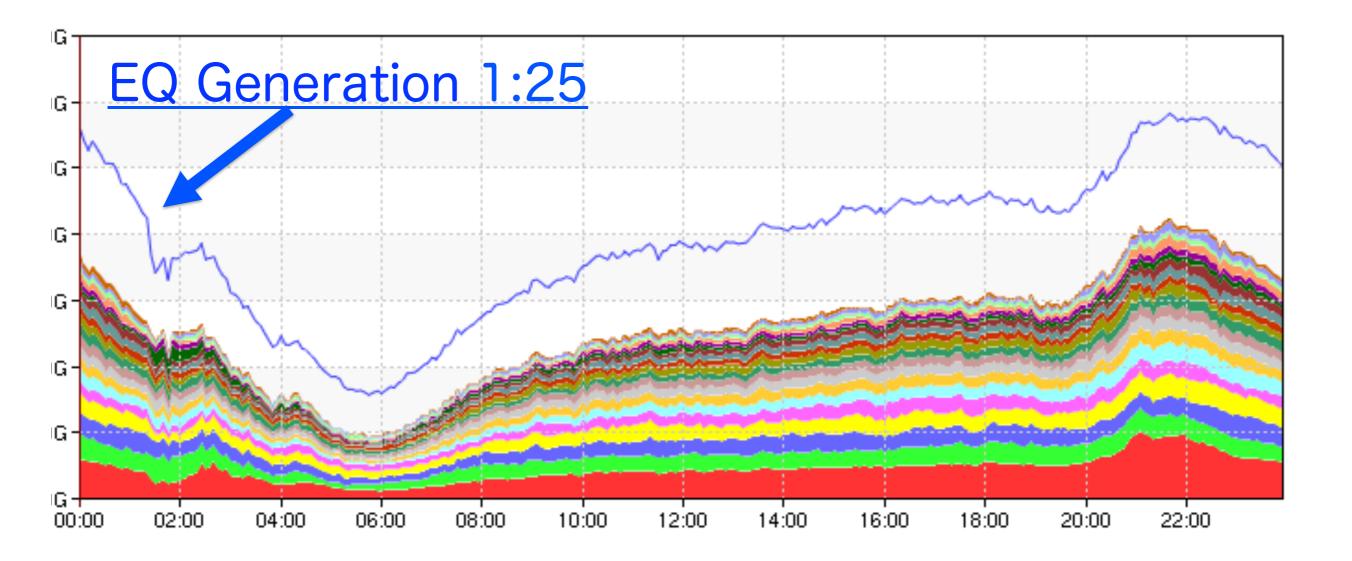
### Internet $\Rightarrow$ AS7679 (4/16 0:00~23:59)

### Traffic (Internet)

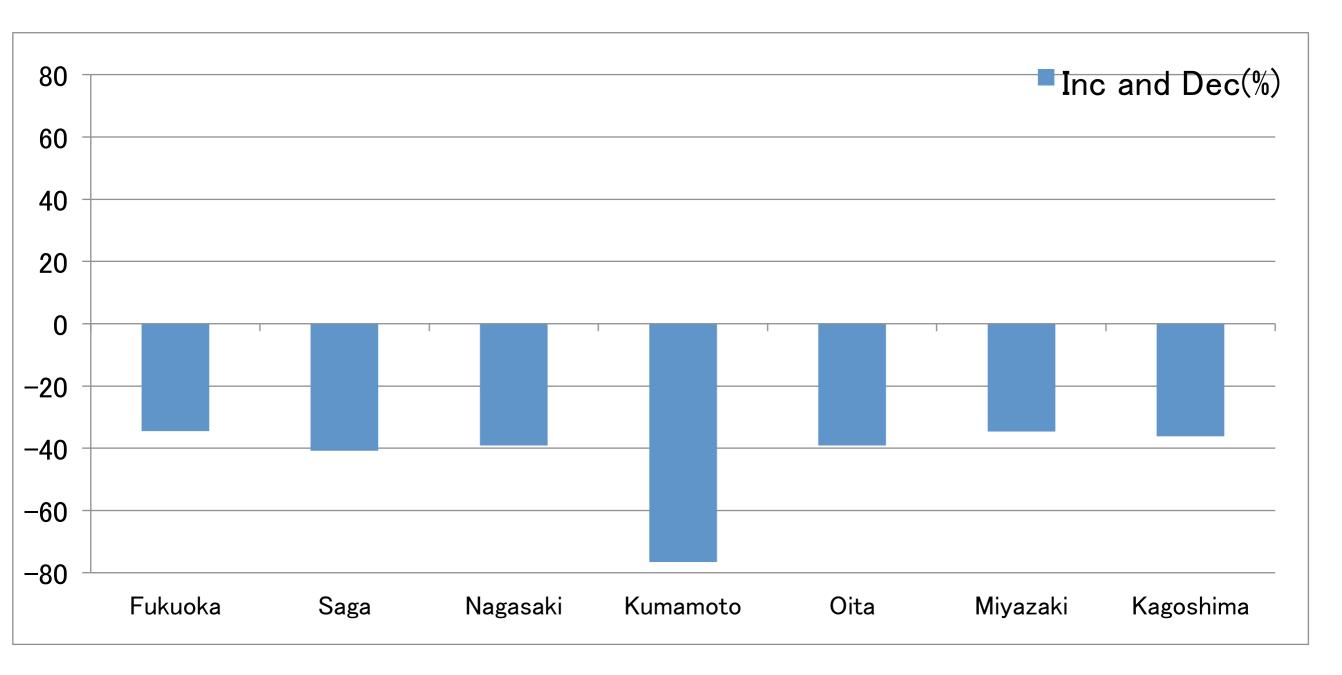
# Percentage of Increase and Decrease of Traffic / Area

(Comparing to 2 hours later from earthquake generation)

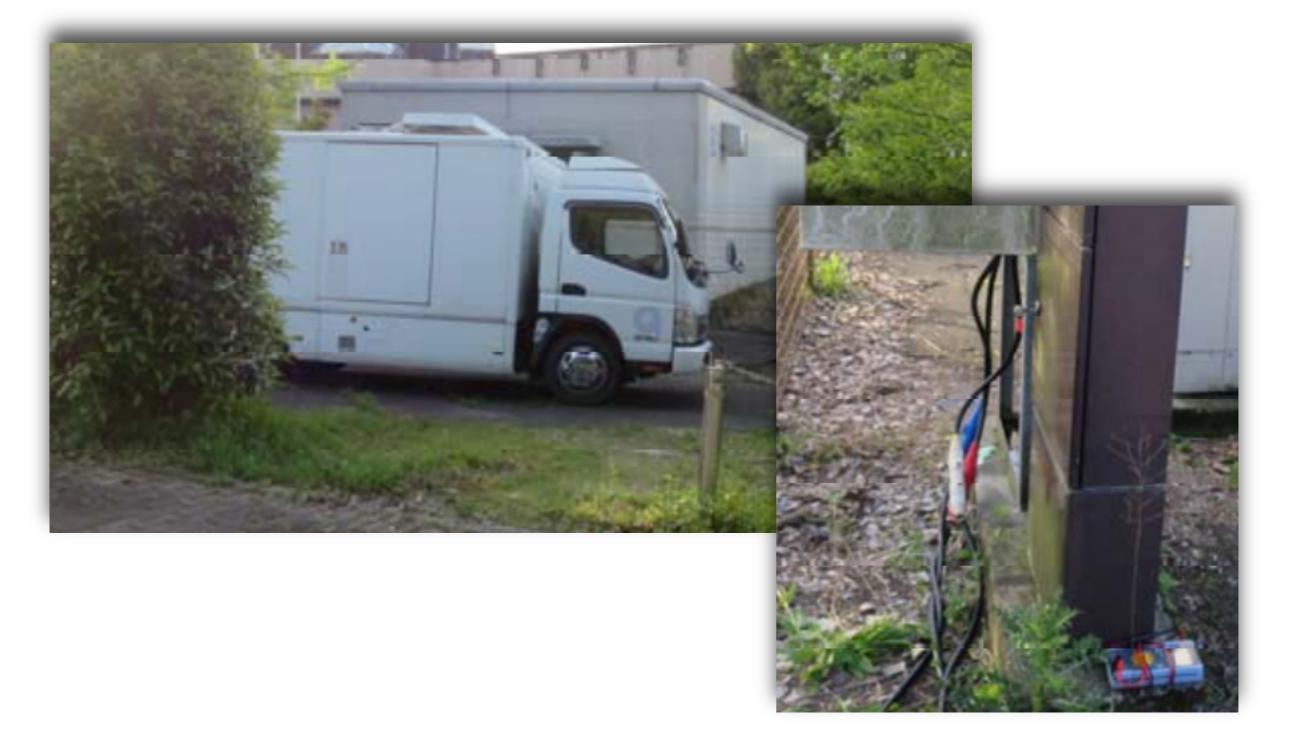
#### Response to Blackout

- Blackout occurred at several centers in Kumamoto area
  - storage batteries temporarily supplied power source for a certain time, corresponding to the size of centers
  - power-supply cars deployed in each zone were dispatched to the spot
    - started power supply and continued it for about 4 days until recovery of the commercial power source by supplying fuel
    - no power outage at the centers

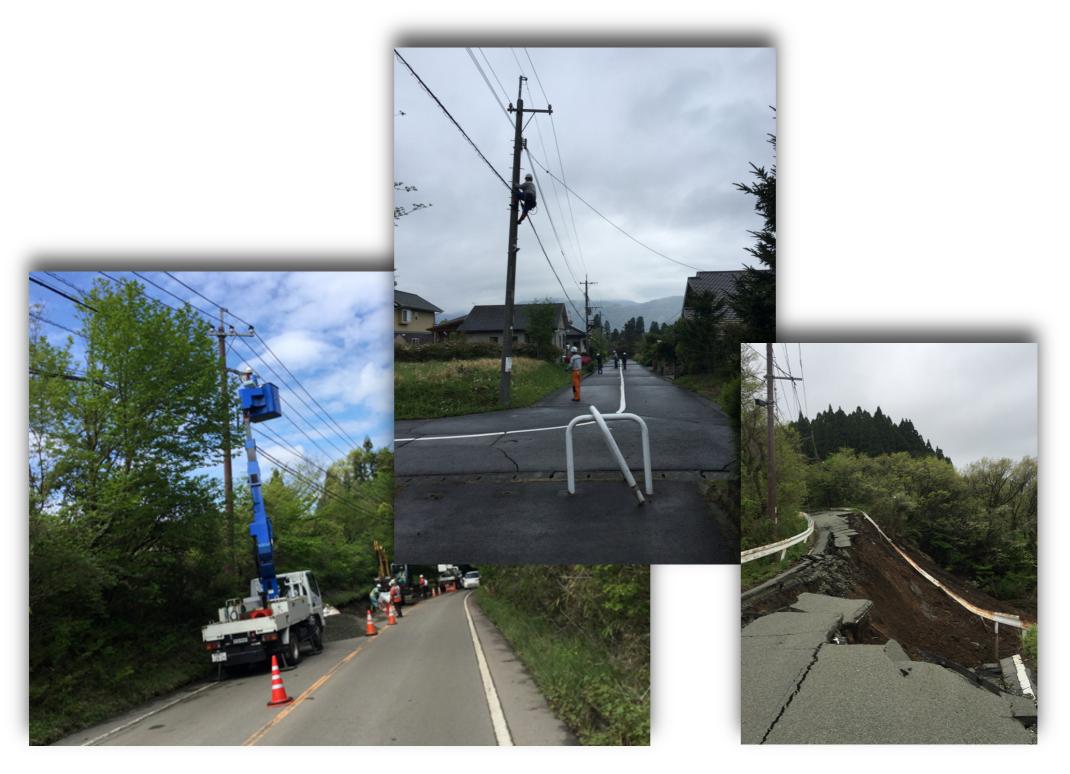
### Response to Fiber Cut

• Optical fibers were cut by a landslide

- Identified the spot and repaired by splicing in a patch

- if not possible, laid new rerouted fibers

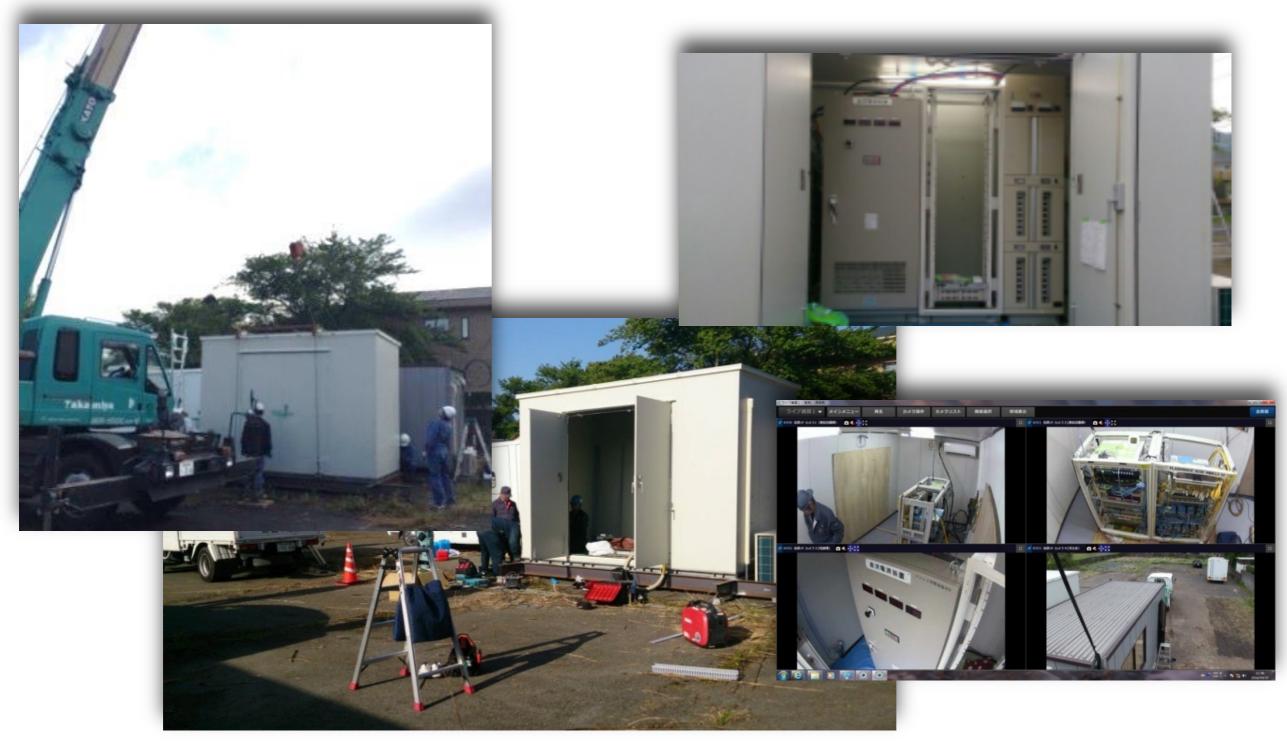
#### Setting Temporary Center Up

• For circuits which are not easy to recover, set a temporary center up.

- negotiate a site for the building, build temporary
  Center, install power supplies
- transport network devices in, install and test
- recovered the circuit with in a few days!!
